HUB REVIEW FINDINGS - GREAT AMERICA STATION

October 16, 2006

MTC Regional Transit Hub Performance Review Project

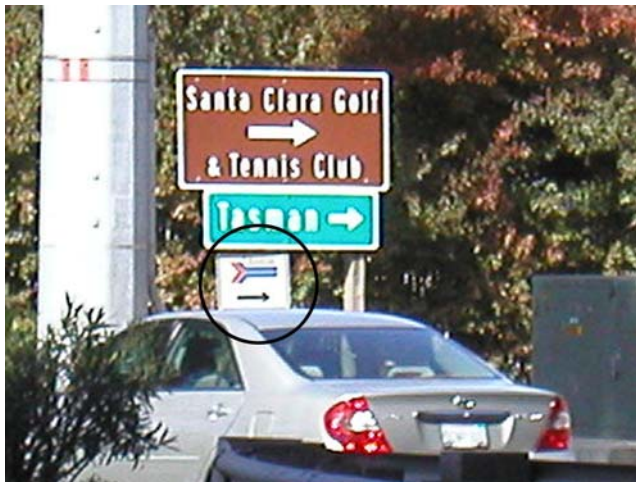
1. Direction to station from Lafayette St. Sign is difficult to see and does not include station name.

- Establish a consistent name for the hub and reinforce this name on all schedules and printed materials (see checklist question #4, photos #2-3);
- Install a pathfinder sign program to help guide passengers to and from the station along local roads and between the Lick Mill LRT station (see checklist questions #1, 2; photos #4-6);
- Use operator logos for ACE, Capital Corridor and VTA shuttles on the pathfinder signage and at hub entrances (see checklist questions #3, 5);

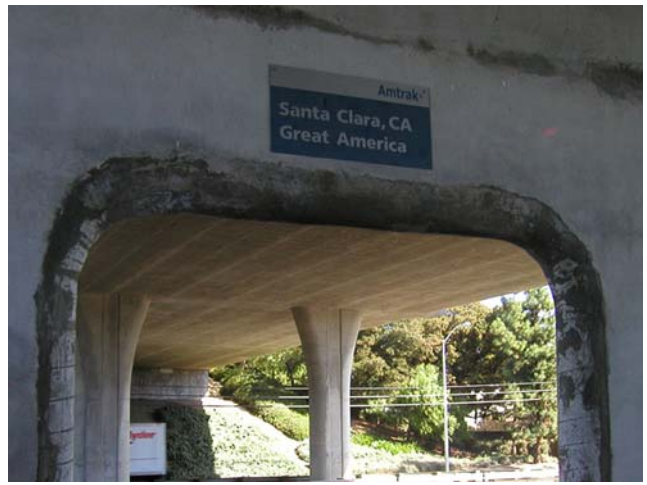
2. Station identification sign.

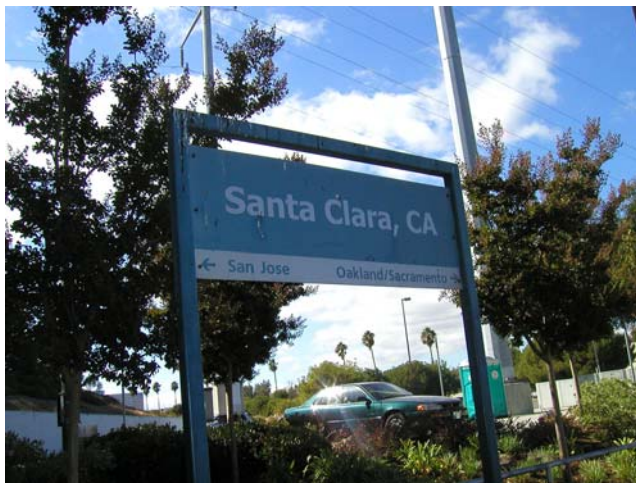
3. Station identification at tracks. Note: Different station name from Photo 2.

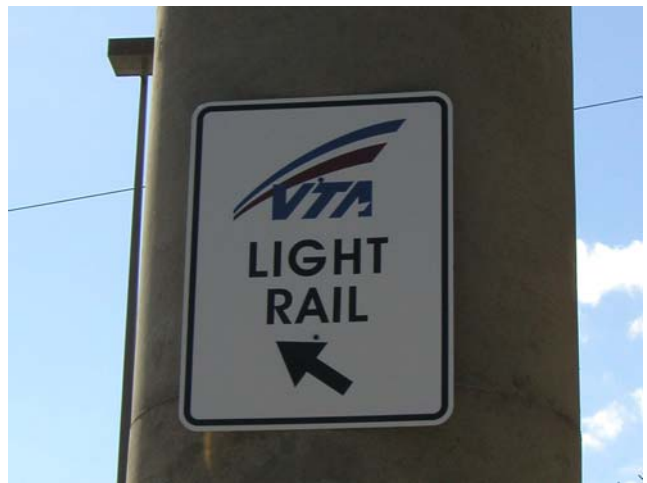
4. Directional signage up stairway to Lick Mill VTA Light Rail Station located on Tasman Drive. Note: Sign does not include LRT station/stop name or distance.

- Install signs at decision points to off-site light rail and bus stops and location of customer information/RTIC installations. Delineate the accessible pathway throughout the hub (see checklist questions #9, 10, photos #4-6);

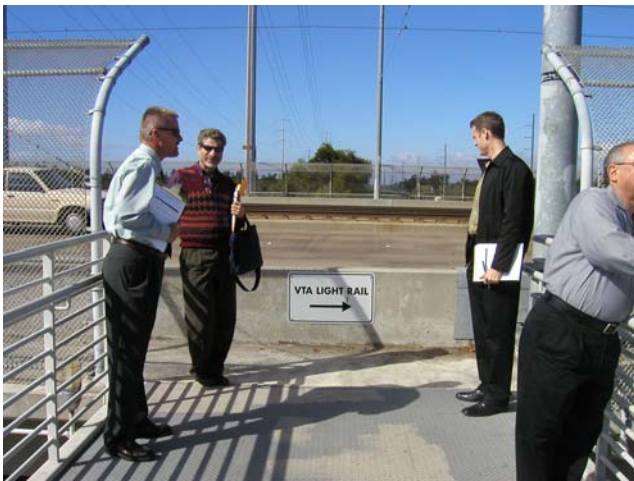
5. Directional signage to Lick Mill LRT Station at top of stairway from Great America Station. Note: Sign does not include LRT station/stop name or distance and is not positioned at eye-level.

- Include walking time or distance to off-site connections (see checklist question #11).
- Include VTA LRT station name (Lick Mill) on directional signage (see checklist question #11, photo #5).

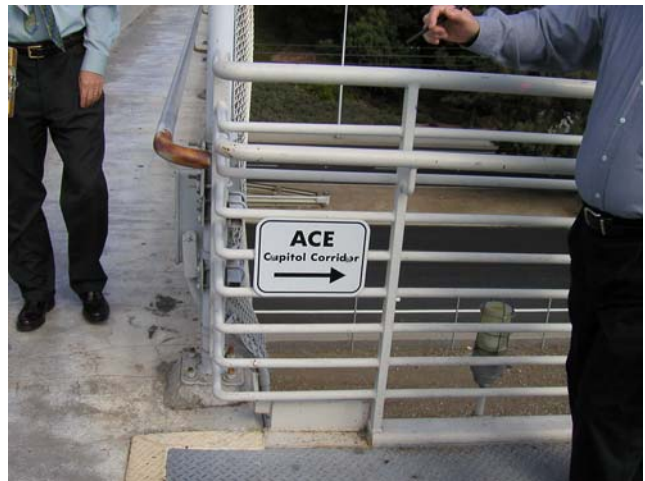
6. Directional signage from top to stairway to Great America Station below. Note: Sign does not include station name and is small and not positioned at eye level.

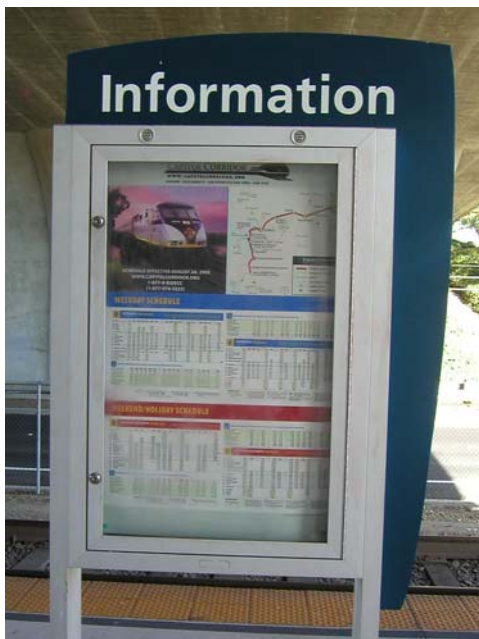
7. Capitol Corridor map and schedule information.

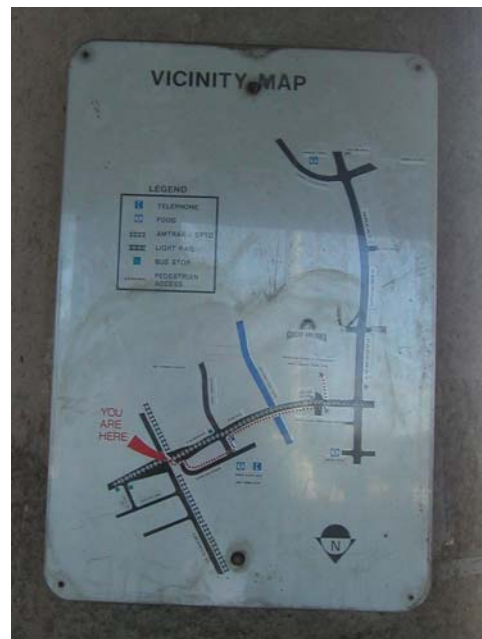
8. Local vicinity map. Note: Shows location of bus stops and LRT station but does not include station name or route numbers. Also does not include location of Lick Mill LRT Station which is closest to this transit hub.

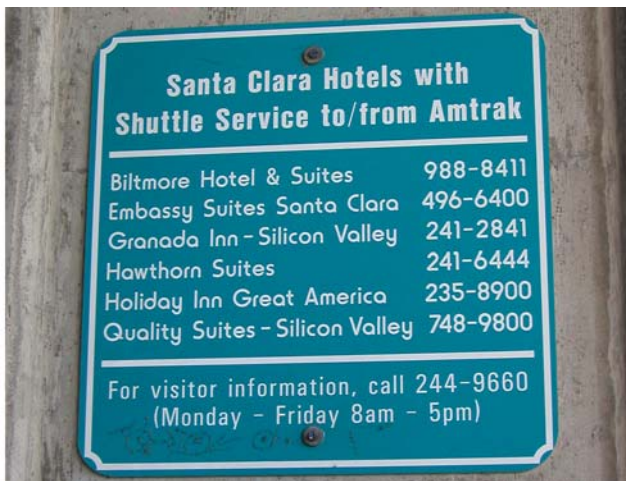
9. Local information placard.

- Centralize customer information and incorporate it with RTIC installations wherever possible (see checklist questions #28-32);
- Establish two locations (near RTIC and at VTA shuttle loading area) where customer information is provided including (see checklist questions #28-32; photos #9-12):
 1. Subregional or system map for local operators;
 2. Schedules and service hours;
 3. Fares and specific system information;
 4. Hub layout map; and
 5. Local vicinity map.
- Update and relocate current local vicinity map; existing map is incomplete and posted too high to meet ADAAG guidelines (see checklist question #30, photo #8);
- Identify ACE ticket booth as such and add hours of operation. The booth can be used for distribution of printed materials (see checklist question #33).

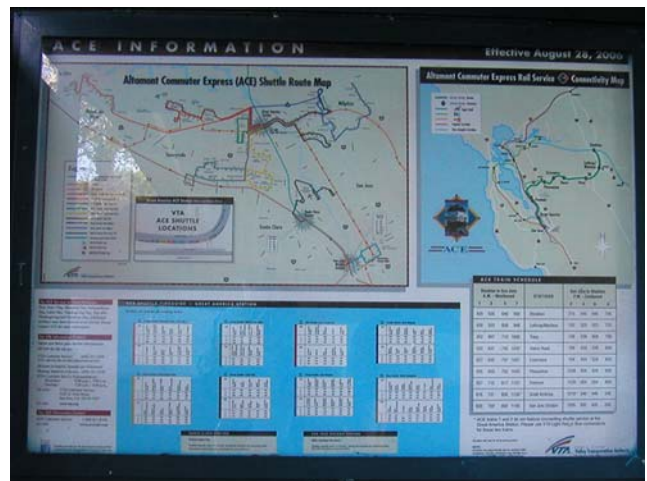
10. ACE information display.

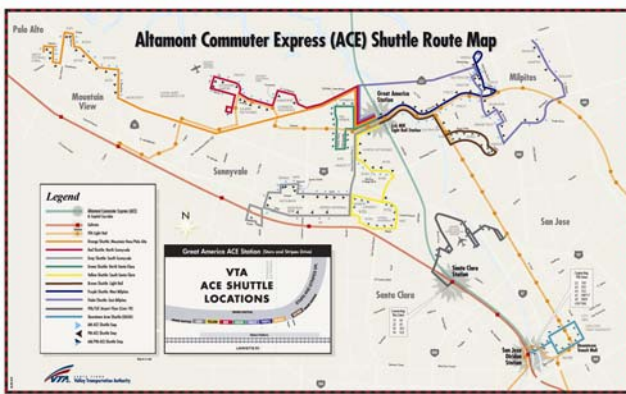
11. Shuttle route map included in ACE display.

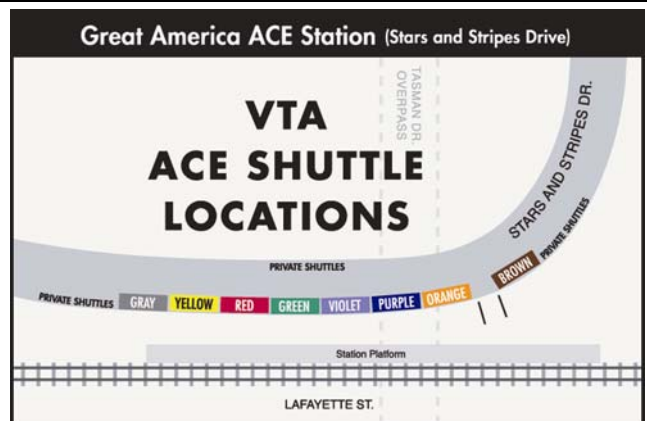
12. Shuttle location map included in ACE display.

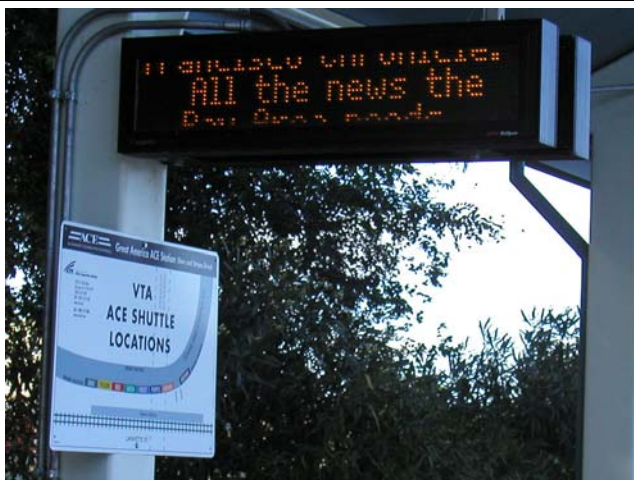
- Currently real-time signs are provided at two locations in the hub: by the ACE ticket booth and at the train shelter (photo #13). These signs appear to be managed by Capital Corridor; however this has yet to be confirmed, as the operators name and logo do not appear anywhere near or on the sign.

13. Real-time/variable signage display.

- Expand existing real-time information for all service providers, particularly ACE, Capital Corridor, VTA LRT and VTA shuttle services (see checklist questions #38, 39);
- Add a real-time display at the shuttle boarding area.
